## RISKS OF CONDENSATE FORMATION AND MOULD GROWTH IN BUILDINGS UNDER LATVIAN CLIMATE CONDITIONS

A. Ozolinsh, A. Jakovich

Laboratory for Mathematical Modelling of Technological and Environmental Processes, University of Latvia,  
8 Zellu Str., Riga LV-1002, LATVIA  
e-mail: andris.jakovics@lu.lv

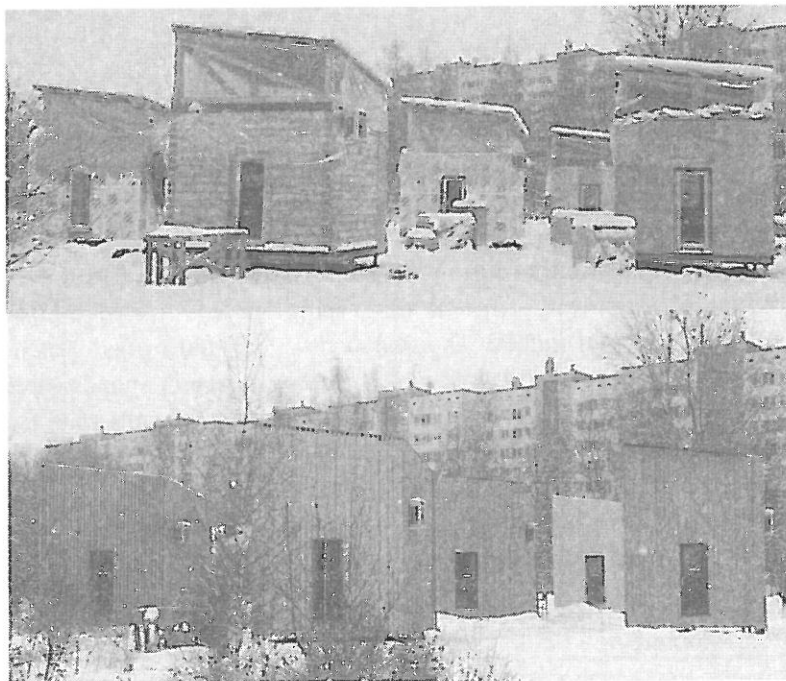
Fig 1. Polygon of test stands. Above: in the front – test stand of wooden logs; to the left – test stand of aerated concrete; at the back – test stand of plywood panels. Below: the completed test stands.

For the first time in Riga (Latvia) five test stands have been built for the research purposes (see Fig. 1), with the purpose to verify the energy efficiency and sustainability of the solutions developed for construction of external walls from local raw materials (ceramic blocks, foam concrete, wood, plywood, fibrolite, granules, sawdust plates, etc.) taking into account the Latvian climate conditions. The test stands are equipped with a full system for monitoring, collection and storage of data. On the south wall of such a stand the windows are made in order to analyse the influence of solar radiation on the energy consumption for heating and cooling and on the indoor thermal comfort conditions (more information and results are available in [6]).

The data on the wind speed and direction as well as on the solar influence (see, e.g. [10]) were not used in the simulations, because the walls of test stands are protected by the ventilated facade (see Fig. 1). It is assumed that the temperature and relative humidity of the ventilated air layer are the same as those outdoors. The heat exchange coefficient is the same as that for the interior air.
